Cluff Lake Decommissioning Project

[Excerpted from pages 185-187 of the 2012 NAS Report “Uranium Mining in Virginia”.]

BOX 6.1
Cluff Lake Decommissioning Project

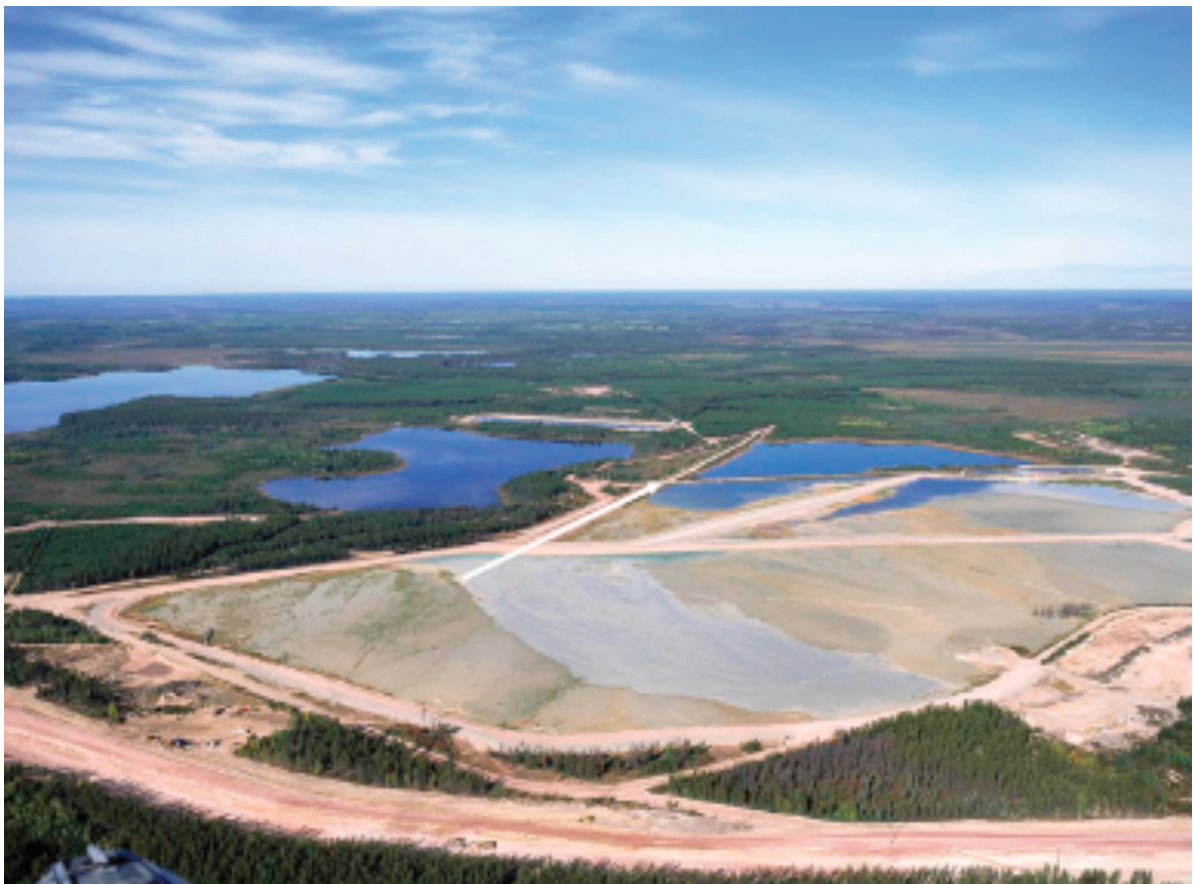
FIGURE 6.1 Tailings management area at Cluff Lake in 1999, Saskatchewan, Canada. The tailings are held behind an earthen dam. SOURCE: AREVA Resources Canada, Inc.

Additional potential environmental hazards at the Cluff Lake site include the flooded mine workings and the tailings management area (Figure 6.1). The flooded underground mines represent a source of groundwater contamination and, if allowed to overflow, a potential surface water contamination source as well. The tailings management area was constructed as an unlined abovegrade facility, using an earthen dam to retain both solid and liquid tailings and enable chemical treatment of the mill effluent prior to discharge into Snake Creek and Island Lake. The tailings management area represents the principal on-site source of potential long-term environmental effects, although geotechnical evaluations of the earthen dam determined it to be stable, structurally sound, and in compliance with all design specifications. Given its location in a topographic low, constructed surface diversions were employed to isolate the tailings management area from the erosive effects of inflowing surface water.
