Spent Fuel Removal at Fukushima

- is the mission really accomplished?"

Mission to remove used fuel complete at Fukushima

by World Nuclear News, November 5, 2014

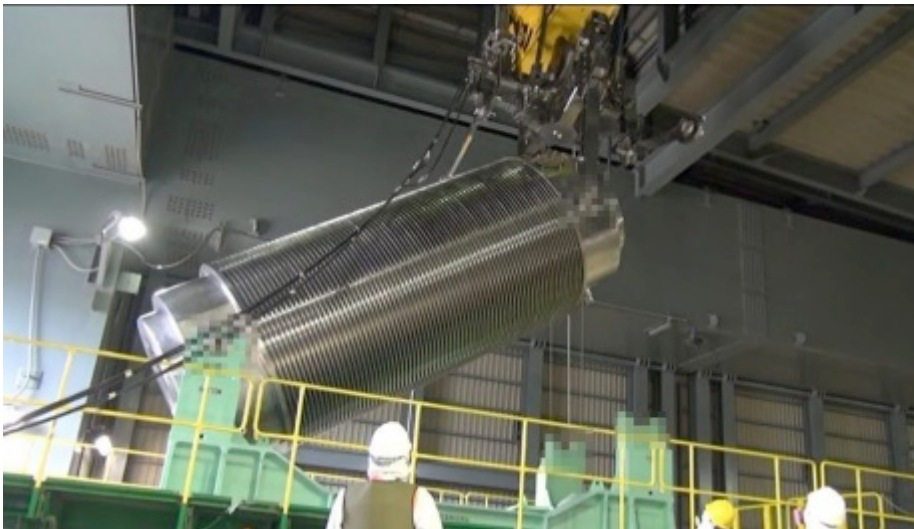
The cask holding the last used fuel assembly is moved to the shared storage pool. (Image: Tepco)

Since last November, the used fuel assemblies in unit 4's storage pool have been removed one by one from storage racks and placed into a transportation cask. This has then been moved across the site to be unloaded at the site's shared storage facility. This process was repeated a total of 63 times until all the used fuel had been removed from the pool.
